Model CV40/41

Application

The CV40 is a low pressure, full port, dump valve. It features balanced plug control trim with a quick opening characteristic and an adjustable topworks, The CV40's full port allows for high flow rates, and its soft seat design gives a consistent leak free shut off when the valve closes. The CV40 can be used for discharging liquid or gas from separators, treaters, knockouts or other vessels. Also available are the CV40U, which features an unbalanced metal plug and seat design, good for avoiding sand buildup, and the CV41, offering an open yoke configuration for the valve.

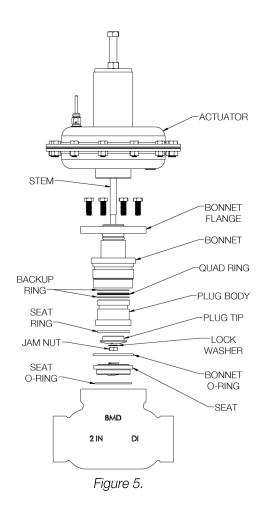
CV40U TRIM REPAIR KITS		
SIZE	TRIM SIZE	PART NO.
2"	1.75"	58-00-0450
	1.00"	58-00-0451

CV40U Trim Repair Kits Include Lapped Trim Set (Cage and Plug), Seat O-ring, Spring Pin, and Bonnet O-ring

Before changing the Trim, make sure the CV40 is closed off from service and completely depressurized. Loosen and remove the Bolts holding on the Bonnet Flange using a 9/16" wrench. Remove the Topworks Assembly by pulling straight up on the Actuator Housing. Remove the Seat using the Seat Removal Tool, see Table 6., and replace the seat O-ring. Once the new O-ring is in place, the Seat can be reinserted. Be sure the Seat is threaded in properly and use the Seat Removal Tool to tighten it down. Unscrew the Jam Nut to remove the Lock Washer and Plug Tip. Use a 1/4" wrench to hold the Stem in place while unscrewing the Jam Nut with a 9/16" wrench to prevent the stem from spinning. Replace the Seat Ring. Next, remove the Plug Body from the Bonnet. If the Plug Body is too difficult to remove, tighten down the Adjusting Bolt until it bottoms out. This will push the Plug Body out of the Bonnet some of the way. Make sure to mark on the Adjusting Bolt where it was set to ensure it is reset in the right position. Using a dry towel or rag, grab the Plug Body and twist as you pull to remove it from the Bonnet. Replace the Quad Ring and two Backup Rings. To reinstall the Plug Body, make sure the two Backup Rings are pressed in all the way around before forcing the Plug Body back into the Bonnet to avoid damaging the Backup Rings. Install the Plug Tip with a new Lock Washer and Jam Nut. Insert the Topworks Assembly into the body and bolt down the bonnet flange.

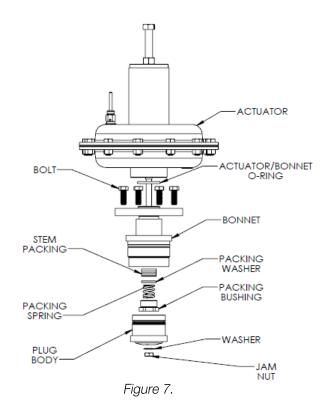
Figure 8.

PACKING REPAIR KIT			
ALL SIZES	58-00-0330

Packing Repair Kit Includes: Stem Packing, Packing Washer, Packing Spring, Packing Bushing, and Stem O-ring

Before replacing the packing, refer to the previous section and follow the instructions until the plug body is removed from the bonnet. Then, using the P.B.R.T. (packing bushing removal tool), partially unscrew the packing bushing to reduce friction on the stem. Unscrew the bonnet from the actuator and pull the two apart. The stem will stay be pulled away with the actuator. Remove the packing bushing using the P.B.R.T. and remove the stem packing, packing spring, and packing washer. The packing itself can either be pushed out from the top of the packing plug or pulled out with a pick tool. Before inserting the new packing be sure to grease each layer and be careful not to scratch the inside bore of the packing as this can cause the valve to leak. Also, be mindful about how the packing is inserted into the bonnet (See figure 8). Inspect the stem for damage as well since any grooves or scratches on it can cause leakage through the packing. Reinstall the packing bushing, without completely tightening, then reinsert the actuator back onto the bonnet. Finish tightening the packing bushing. Make sure the packing bushing is flush on the bonnet before moving forward. Reinstall the plug body into the bonnet then install the bonnet/ actuator assembly onto the body as detailed in the trim replacement section.

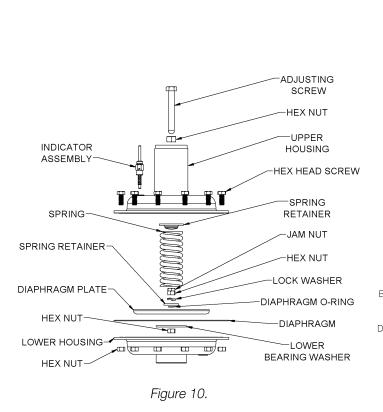
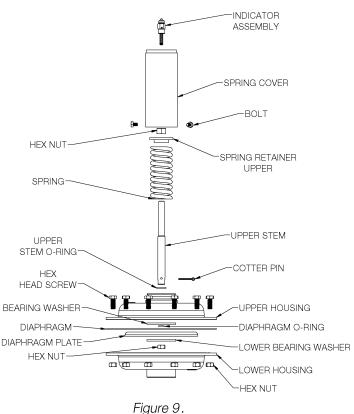
DIAPHRAGM REPAIR KITS		
SIZE	PART NO.	
#35	58-00-0331	
#70	58-00-0500

Actuator Repair Kits Include: Diaphragm, Diaphragm O-ring, Stem O-ring, Actuator/Bonnet O-ring, Upper Stem O-ring, Lock Washer, Hex Nuts, Jam Nuts, and Cotter Pin

For a Reverse Acting Actuator loosen the Adjusting Screw until the Spring is no longer under pressure. For a Direct Acting Actuator remove the Spring Cover, and loosen the Hex Nut that is on top of the Upper Spring Retainer. Unscrew and remove all the Bolts holding the Upper and Lower Housing together. While holding the Hex Nut below the Diaphragm, remove the Jam Nut and Hex Nut from above the diaphragm. (On a direct acting actuator the Upper Stem will be removed instead of the upper Jam Nut and Hex Nut.) Remove the Lock Washer, Diaphragm O-ring, Diaphragm Plate, and Diaphragm. Install a new parts from the Diaphragm Repair Kit and reassemble the housing.

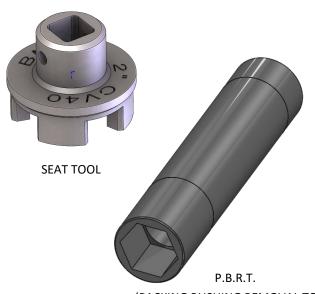
CV40 TOOLS		
Size	Part No.	
2" SEAT	T114	
3" SEAT	T115	
4" SEAT	T116	
P.B.R.T	T105	
TOOL KIT	58-00-0358

* Tool kit includes 2", 3" and 4" seat removal tools, packing bushing removal tool, o-ring pick, and CV10 cage pulling tool.
